Medium Rise Housing Blocks

Structural Investigation of Cantilever Balconies

Project No RP200058

Date: August 2017

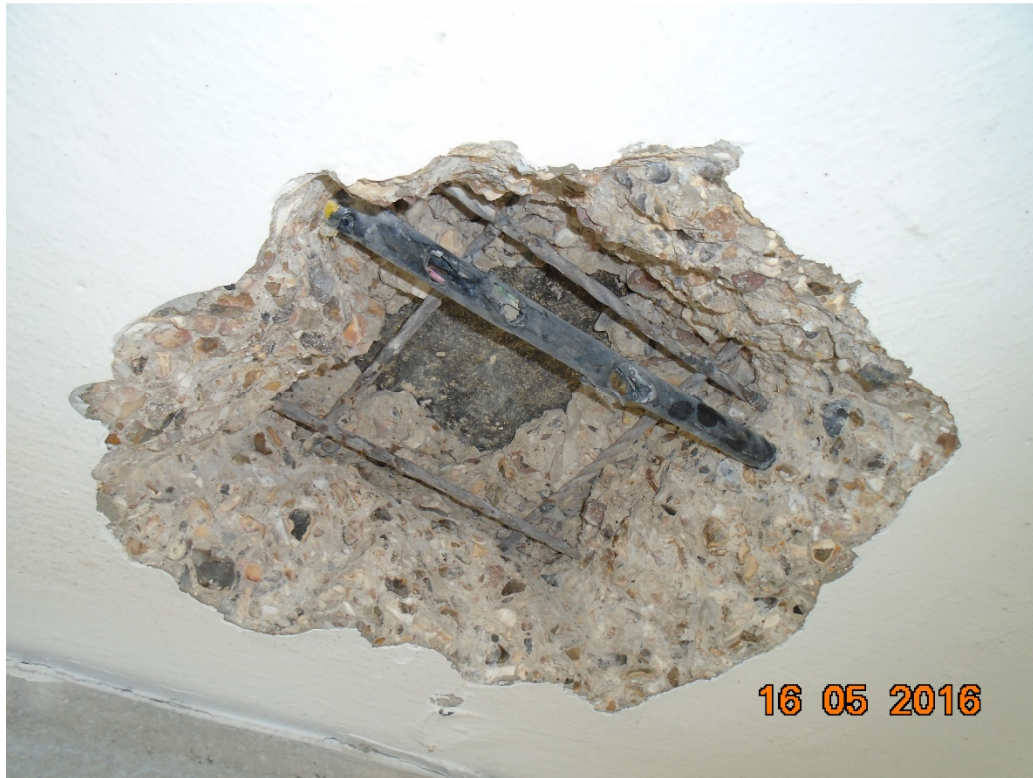
1 Typical Break-Out – 2-74 Golden Grove

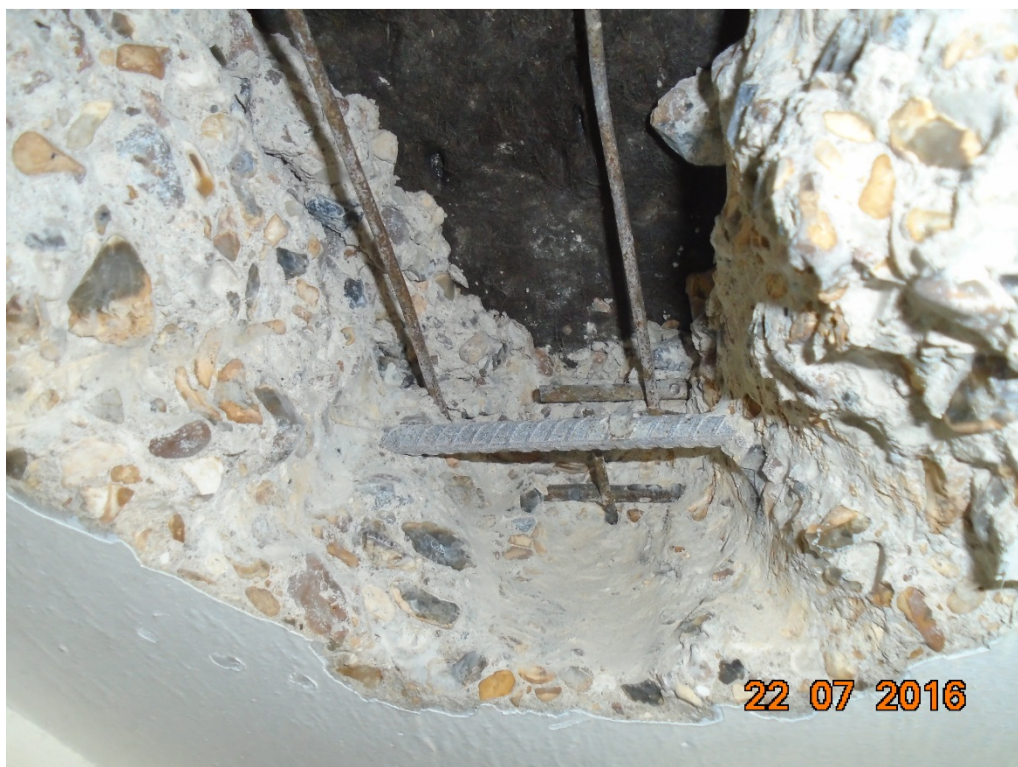
2 Typical Break-Out – 2-74 Golden Grove

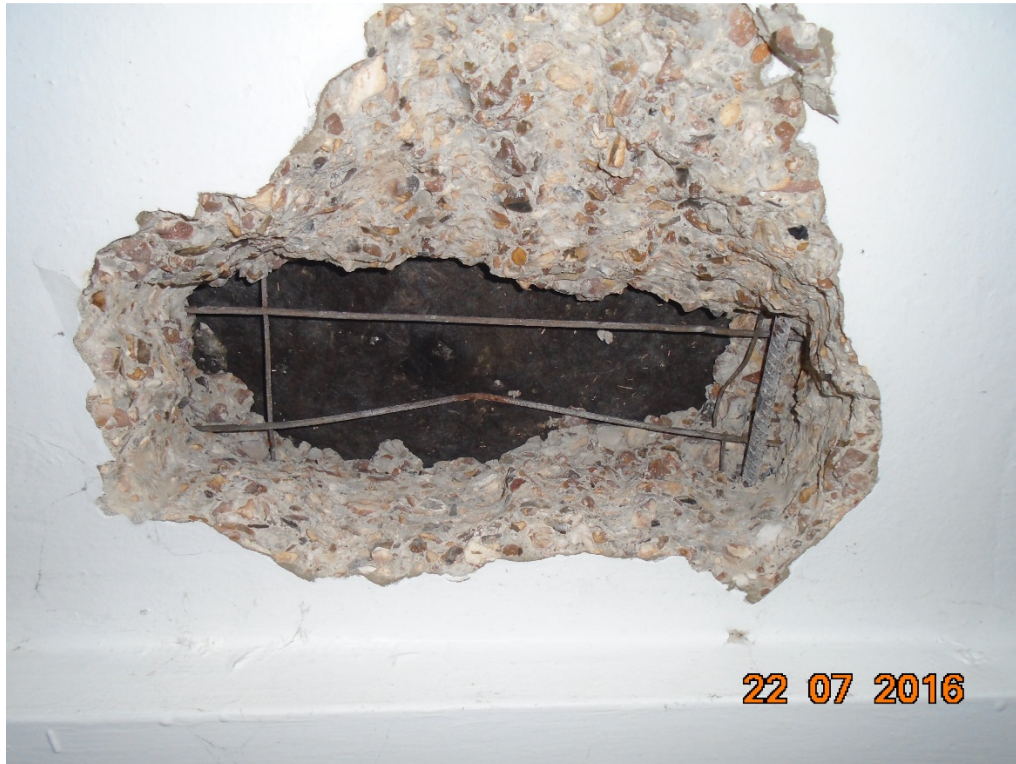
3 Typical Break Out - 39 Golden Grove

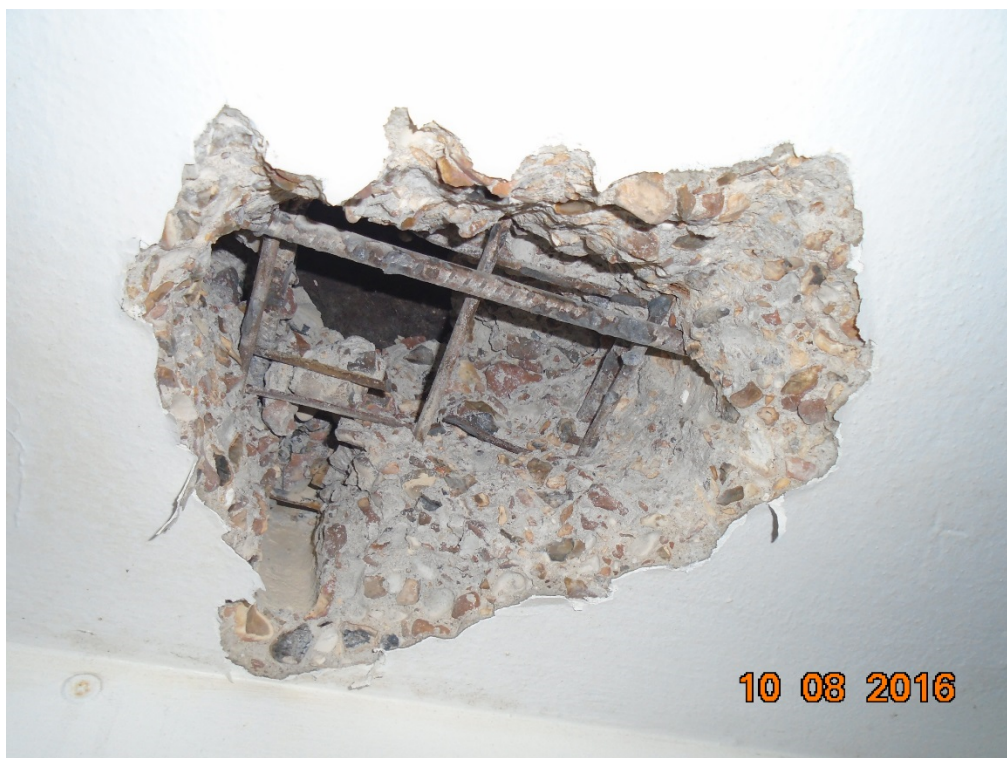
4 Typical break Out – 79 Golden Grove

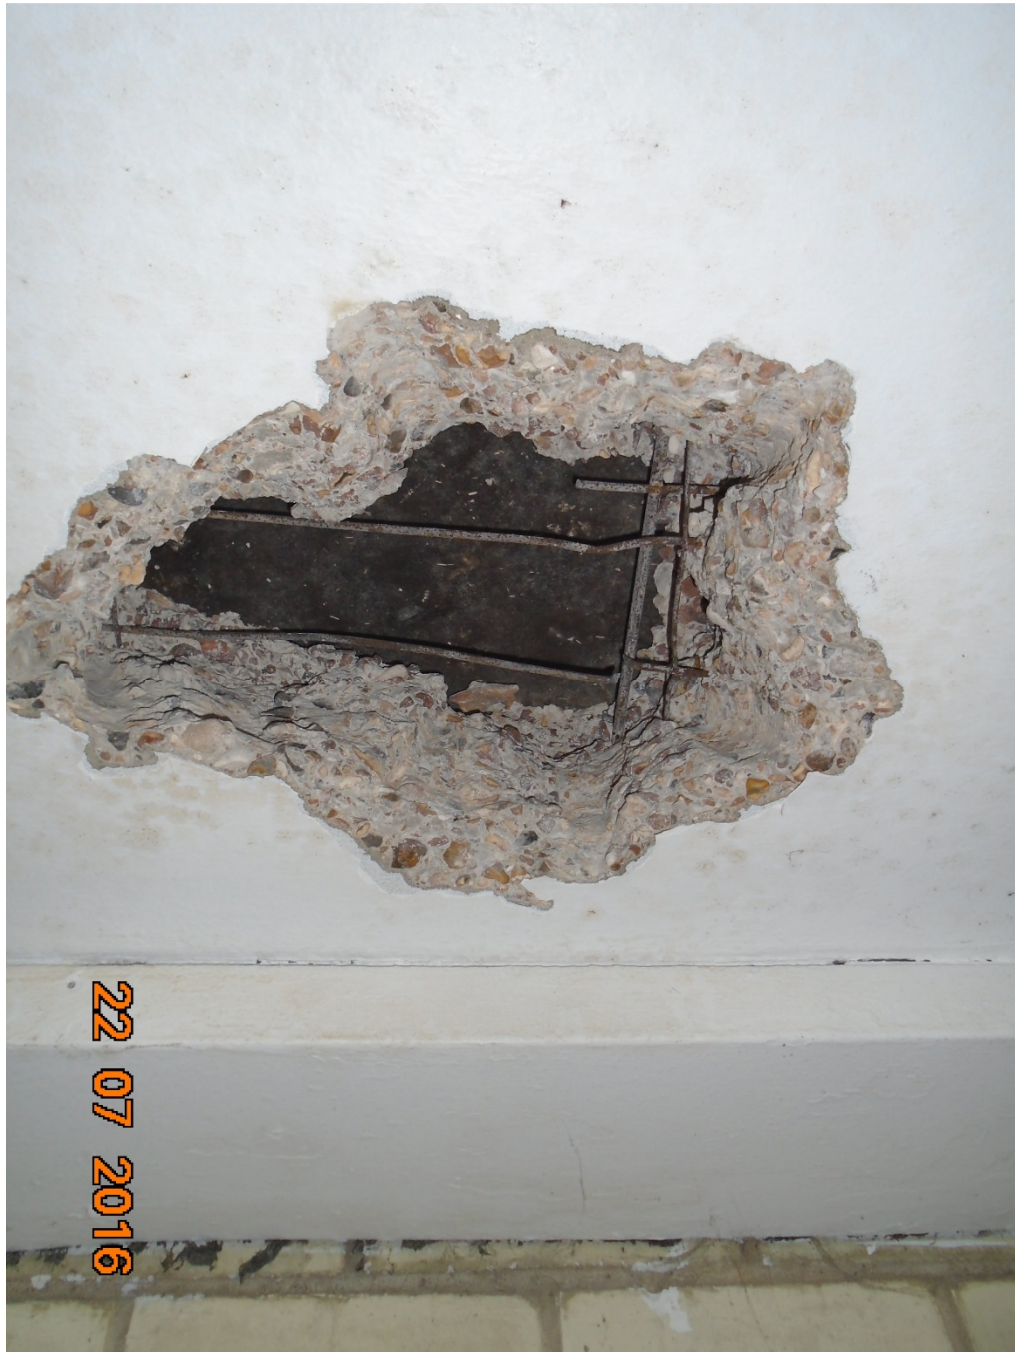
5 Typical Break Out - 6 Golden Grove
