# **Flood Investigation Report**

**Reference:** 19122011/SO163JW

Daisy Dip

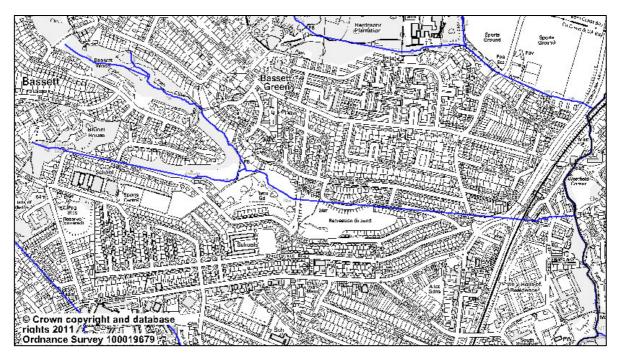
Figure 1: River Network through Bassett Wood/Daisy Dip

Bassett Wood/Daisy Dip is semi-natural woodland and recreational park (managed by the Open Spaces team) which has an ordinary watercourse running along its length. The watercourse has two main tributaries (see Figure 1):

One flows through Bassett Wood which extends from the vicinity of between Spindlewood Close and Redwood Way. A number of small bridges and footpaths cross over the watercourse at various points along its length resulting in small sections being culverted and piped.

The second tributary extends from beyond Copperfield Road and is culverted beneath Copperfield Road until it reaches Daisy Dip.

The converged watercourse flows through Daisy Dip at its lowest point and enters a culvert, protected by a trash screen, under Lobelia Road which directs the water east and eventually enters Monks Brook.
