Asbestos Survey

**Admin Unit, SHIRLEY TOWERS, MILNER STREET,
SOUTHAMPTON**

| Property Reference | 4339100005 | Date printed | 18 February 2019 |

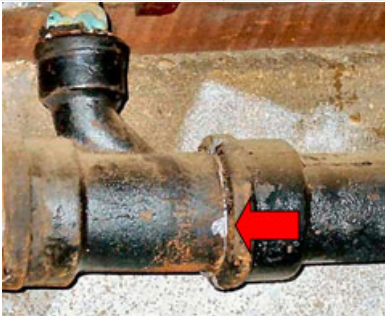
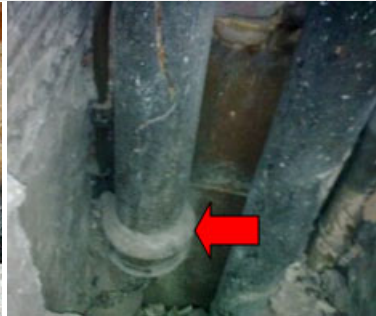
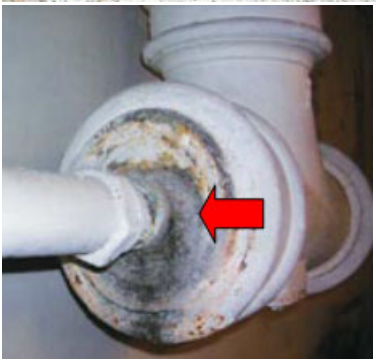
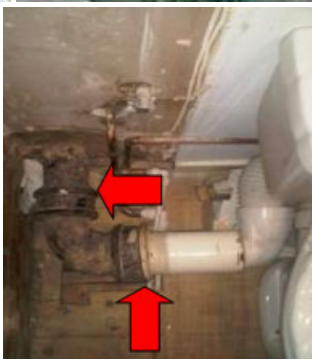
| Location | Material Type | Sampled | Extent | Condition | Damage Risk | Surface Treatment | Asbestos Type | Asbestos Content | Risk Category |
|--|---|--|---|--|---|---|---|---|---|
| <p>Incident 481 of 481 Throughout Cast Iron Waste Pipe - Packing</p> | | | | | | | | | |

| Location | Material Type | Sampled | Extent | Condition | Damage Risk | Surface Treatment | Asbestos Type | Asbestos Content | Risk Category |
|---|---|---|---|---|---|---|---|---|---|
| Comments: Amosite and/or chrysotile may be present as packing around pipe connections e.g. with toilet. Any visible or potential packing material must be assessed prior to any likely disturbance, or the presence of asbestos must be assumed and managed accordingly. Work on this material is typically classified as notifiable non-licensed work. Please examine the example photographs below:- | | | | | | | | | |
