Visit to Marhill Copse 12th June 2020 – Preliminary Comments

Mark Carter FICFor. MRICS M.Arbor.A. Dip.Arb.(RFS) LANTRA
Professional Tree Inspector

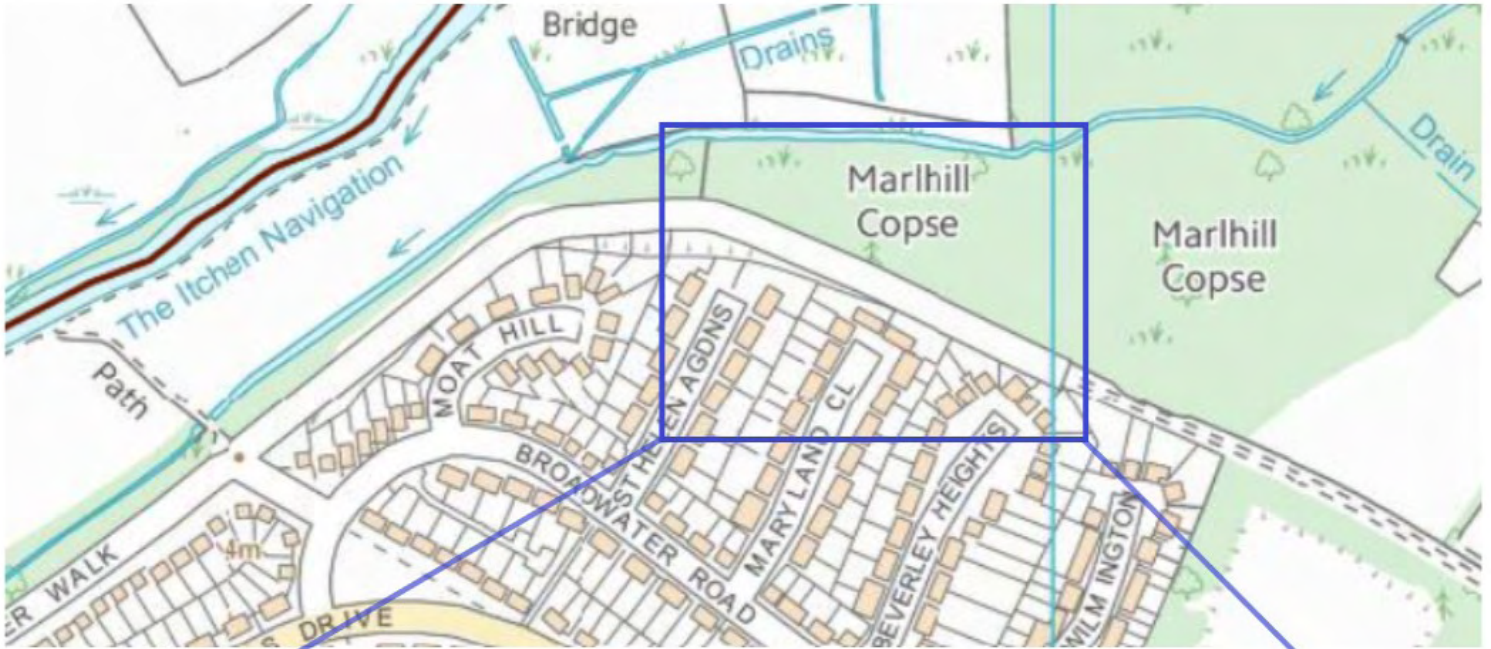
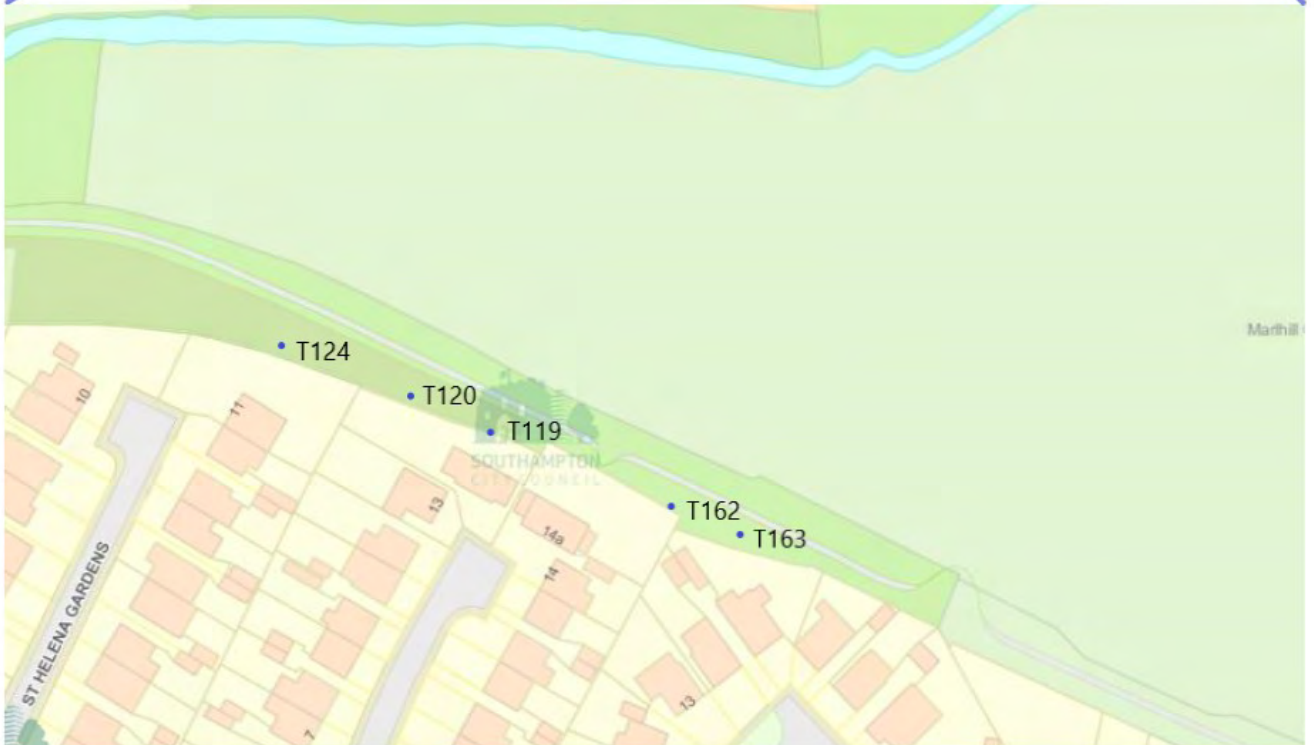
March 2020 - Marlhill Copse
TPO application - Tree Positions

- The trees in question are numbered T119, T120 and T124. These numbers referred to the numbers indicated in the attached plan that was supplied by Richard Buxton.
