### 30 Old Northam Road

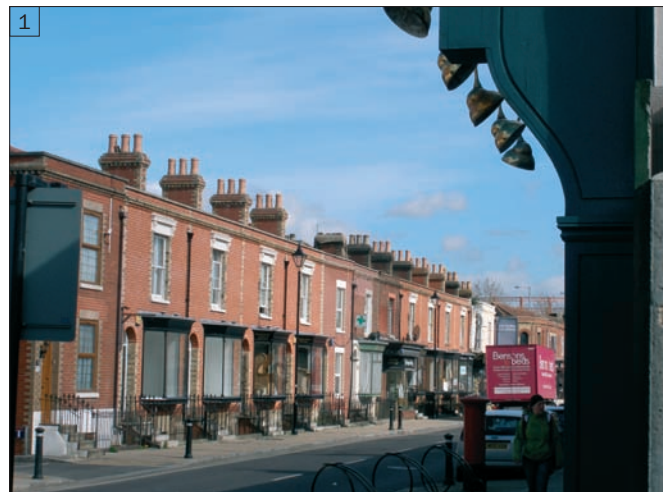
There is a good survival of late nineteenth century shopfronts to the three storey group to the eastern end. These and the oriel windows to the group on the northern side of the road create a very pleasing rhythm to the facades and this is complemented by the single sash to each bay and the chimneys to the ridge providing interest to the skyline.

**01** A consistent rhythm to the streetscape of Old Northam Road  
**02** Views west are dominated by the Travel Lodge to Six Dials  
**03** Views east are dominated by the gas holders to the north of the football stadium

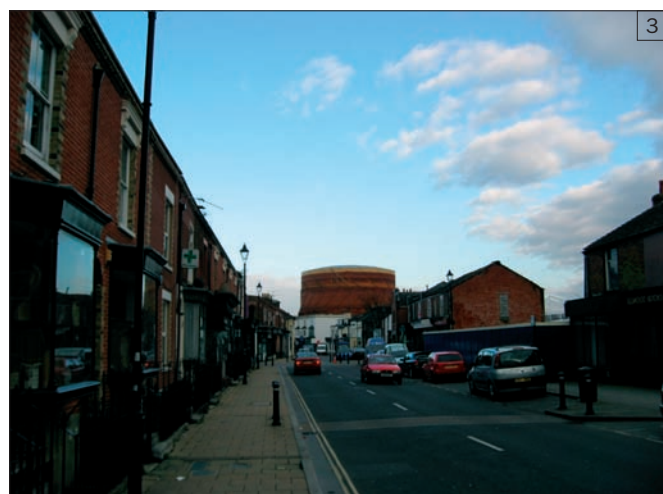
To the east are the locally listed gas holders which dominate and close views east and St Mary's Stadium (CA43) is glimpsed through gaps in the south side of the road and then revealed as the east end of Old Northam Road is reached.
