**COMBINED STAGE 1 AND 2 ROAD SAFETY AUDIT
PROPOSED PUBLIC REALM SCHEME
SALISBURY ROAD
UNIVERSITY OF SOUTHAMPTON**

February 2016

Project Title: COMBINED STAGE 1 AND 2 ROAD SAFETY AUDIT SALISBURY ROAD, UNIVERSITY OF SOUTHAMPTON

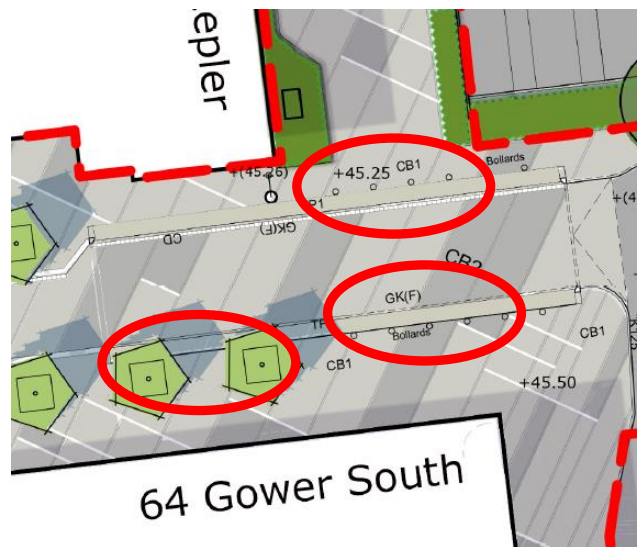
Location: Proposed flush pedestrian crossing on Salisbury Road

Summary: Bollards and street trees could be hazardous to the visually impaired

Bollards are proposed along the north and south side of the crossing point with the likely intention of deterring vehicles obstructing the footway. These bollards could be hazardous to visually impaired pedestrians using the crossing as they may not be aware of their presence. The street trees at the western end, although not on the main desire line, may also form a hazard.

Recommendation: Rationalise the number of the number of bollards to ensure the main desire line remains clear of obstructions. Shorten the length of tactile paving so that it extends as far as the first street tree on the south side of the crossing. A short depth of corduroy warning paving could be provided on the kerb line of the remainder of the flush section on the north and south side to warn the visually impaired of the presence of the carriageway.

Any tactile paving used should where possible, have a colour contrast with the surrounding materials.

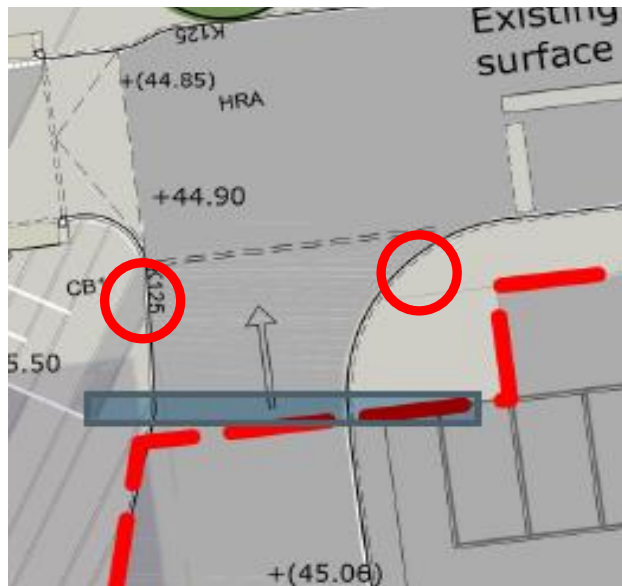
Location: Access just east of 64 Gower South

Summary: Lack of tactile paving could cause confusion for the visually impaired

An existing egress is the just to the west of the proposed Gower South Building. This access currently has tactile paving across the bell mouth. The proposed drawings show no tactile paving on the west side of the access. The visually impaired may have difficulty negotiating this access and could be guided into the carriageway were conflict with vehicles is more likely.

Recommendation: Provide appropriate tactile paving across this access. Any tactile paving used should where possible, have a colour contrast with the surrounding materials.
